**GERA 77**

Pune, Maharashtra, India  
October 2008

**CONCRETE  
WATERPROOFING**

# PROJECT CASESTUDY

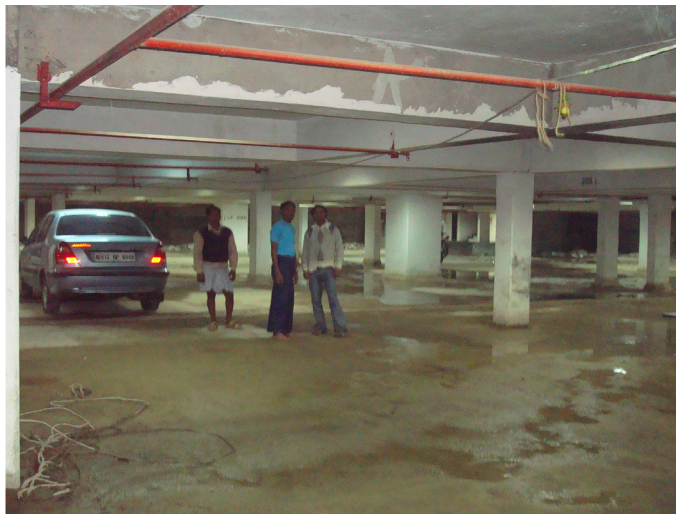
Gera 77 is a commercial building in Pune, (Maharashtra,) India, that required waterproofing in its basement parking facility. There was a large quantity of water seeping through the retaining walls while some points had active leaking. Water was accumulating in the basement and required continuous pumping.

The main cause was active leakage sources in the ramp areas and even some areas on the floor level. The developer had provided drains for the main area of leakage and was pumping out water every 15 minutes. The floor area also had active sources under the PCC cover. All the walls were covered with thick plaster. If the water was not pumped out, it would accumulate up to 1.5ft on the basement floor within 45 minutes.

**Five hp2 pumps working continuously**
