## **CRACK LEAK REPAIR**

LR 5104-033 REVISION DATE 2024

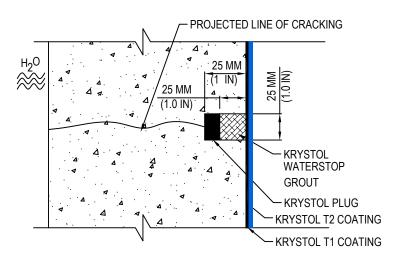
NEGATIVE SIDE LEAK REPAIR

POSITIVE SIDE LEAK REPAIR

CHISEL TO CREATE A CHASE ALONG THE ENTIRE LENGTH OF THE LEAKING CRACK OR JOINT TO THE REQUIRED 25 MM X 25 MM (1" X 1.")

- 1. APPLY KRYSTOL PLUG TO PREPARED CHASE TO STOP FLOWING WATER.
- 2. TIGHTLY PACK REMAINING CHASE WITH KRYSTOL WATERSTOP GROUT
- 3. POSITIVE SIDE WATERPROOF ENTIRE WALL OR SLAB WITH KRYSTOL T1.
- 4. NEGATIVE SIDE ADDITIONAL COAT AFTER 3 TO 4 HOURS WITH KRYSTOL T2.
