CASE STUDY

Bharat Oman Refinery

Bina, India (2011)

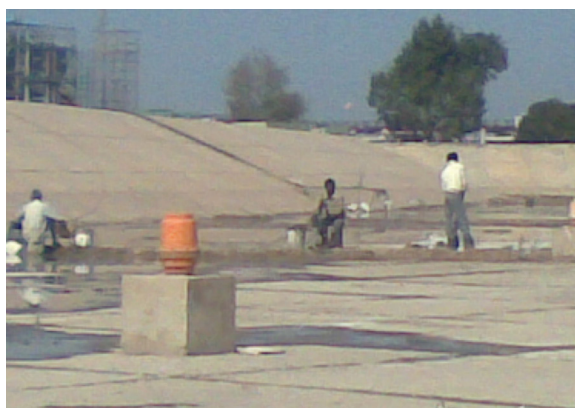
Repair work on the reservoir.

The team used Kryton's Krystol T1 and T2 Waterproofing System to repair the leaks from the positive side. The joints were treated with Krystol T1, Krystol Bari-Cote and Krystol Plug and the entire reservoir received a coating of the Krystol T1 & T2 surface-applied waterproofing system. The solution saved the owners time and labour costs.

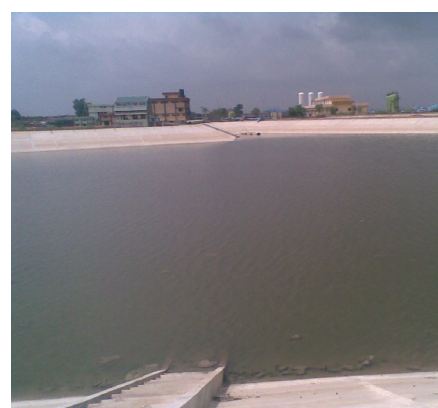
The reservoir was refilled after the repair work.

The water levels were tested after refilling and measurements were taken for three days to ensure there was no further water leakage. There was none and the project was a success.
